Results of the NIST National Ball Plate Round Robin

**G. W. Caskey, S. D. Phillips, and
B. R. Borchardt**

National Institute of Standards and
Technology,
Gaithersburg, MD 20899-0001

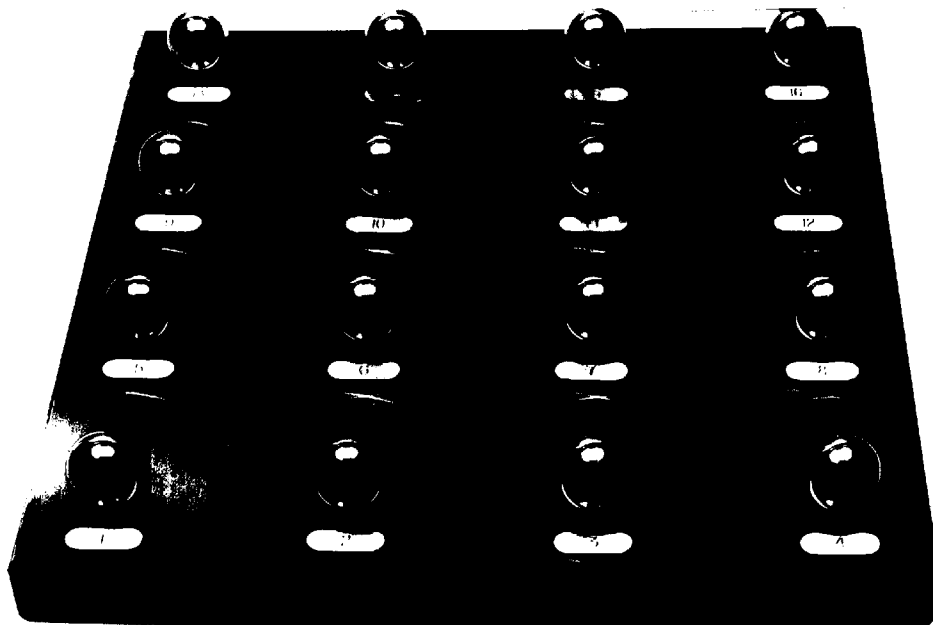
Fig. 1. The ball plate used in the round robin. The spheres are numbered sequentially from left to right, by rows, beginning with number 1 in the lower left corner.

The ball plate used for this round robin, shown in Fig. 1, is a two-dimensional array of tool steel balls mounted on a base plate. Attached to the ball plate are 16 spheres equally spaced on an 80 mm by 80 mm grid. Nominal sphere center coordinates and their distance from sphere number 1 (the defined plate coordinate system origin) are given in Table 1. Each sphere is 25.4 mm (1 in) in diameter and is round to better than 0.15 μm . The base of the ball plate is mild carbon steel with three semi-kinematic pads ground on the bottom for mounting. One of the primary concerns was that the ball plate be constructed of a manageable size and weight to facilitate handling. At the same time, it was equally important that the plate be sufficiently robust to prevent permanent deformation due to normal handling. Therefore, the ball plate was limited to 240 mm by 240 mm, along its length and width, but was made relatively massive in thickness (25 mm) to accommodate these competing requirements.

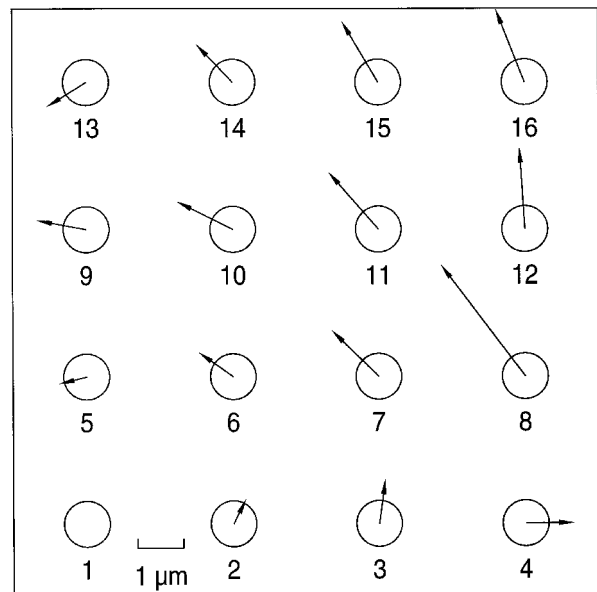
Fig. 2. Graphical representation of shift in ball plate sphere centers. The maximum change in center coordinates, in excess of 3 μm , occurred on ball number 8.

During the remeasurement of the plate by NIST at the end of the round robin, it was discovered that there was an apparent systematic shift in sphere center. The magnitude and direction of the change in these coordinates, shown graphically in Fig. 2, is consistent with a distortion occurring predominately on the right side of the plate. The average magnitude of the ball center coordinate change in this area was approximately 2 μm , with a maximum change of more than 3 μm occurring at ball number 8.

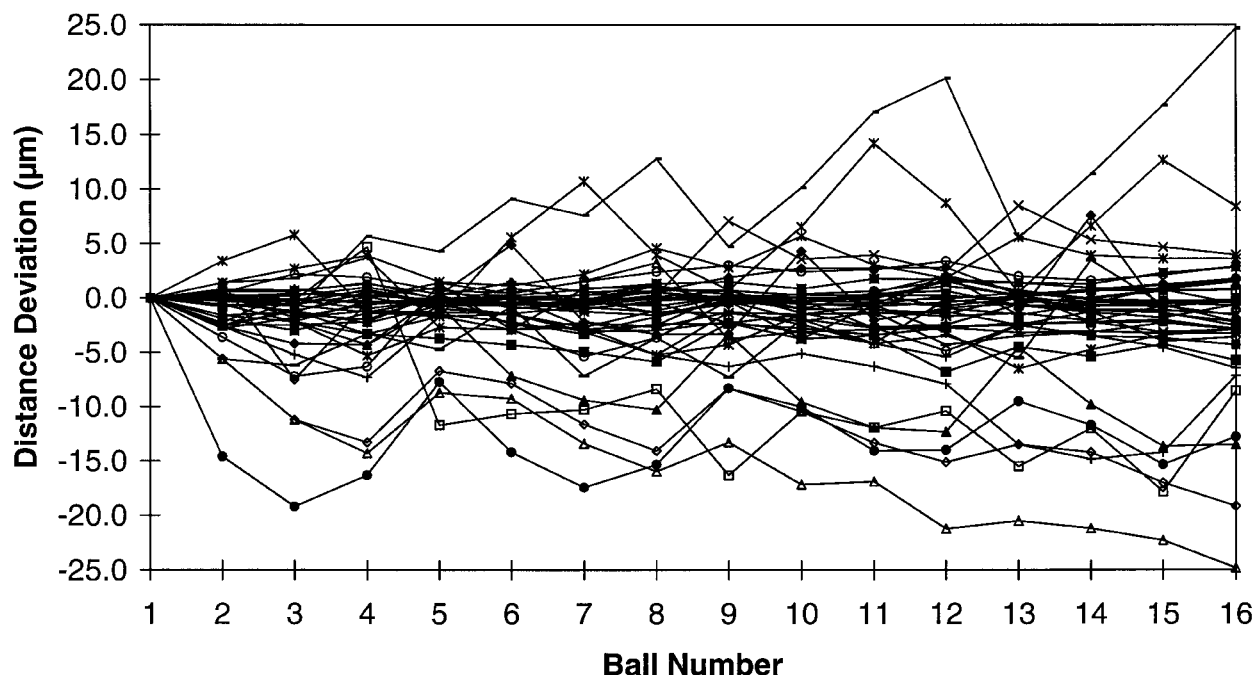
Fig. 3. The deviations in the sphere distances, between ball number 1 and the remaining 15 balls, with respect to the NIST calibrated values.

The results of the ball plate round robin are shown in Figs. 3 through 7. Figure 3 shows the deviations in distance from ball number 1 (the ball plate measurement system origin) for all of the participants. The authors realize that choosing to analyze only the set of distances from ball number 1 can have the effect of biasing the individual participants' deviation data since the measurement of ball number 1 is itself not without error. However, the prescribed procedure for establishing a common ball plate coordinate system was very much analogous to establishing a part coordinate system and/or part datums which are integral to the discrete part measurement process with a CMM. Therefore, analyzing the data in this way was more closely aligned with the objectives of the round robin.

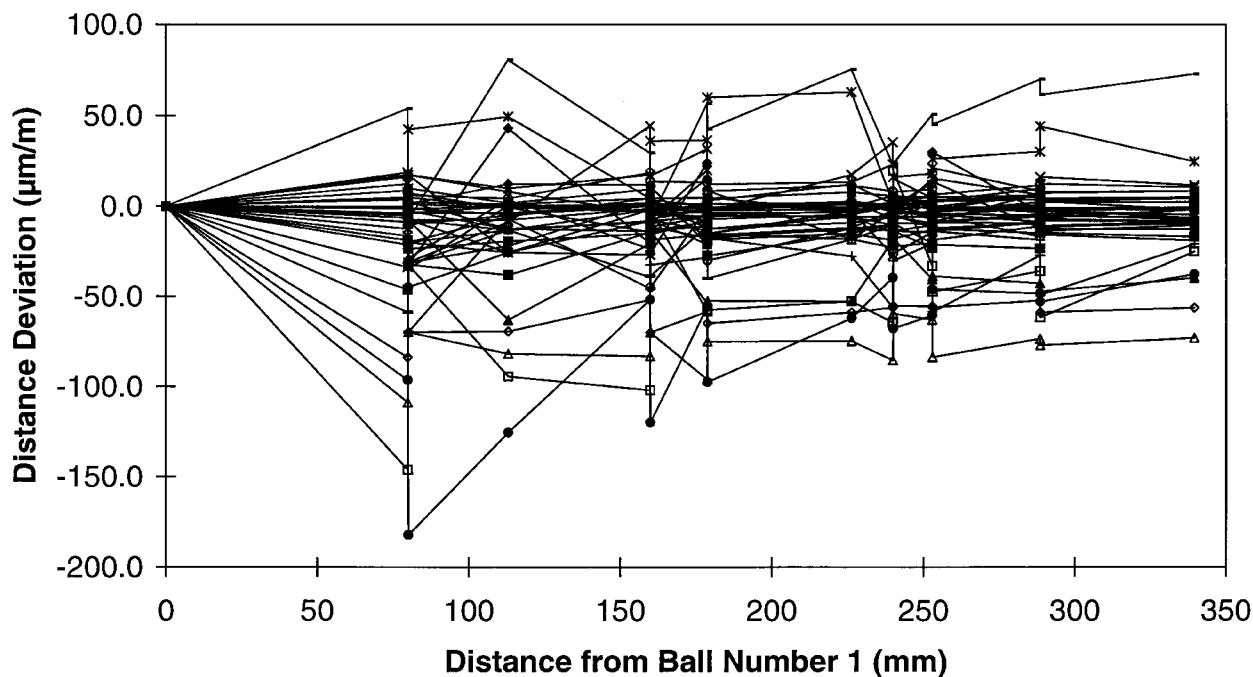
Fig. 4. The distance deviations from Fig. 1 expressed as a fraction of the distance from ball number 1.

A similar plot, Fig. 4, shows these same distance deviations expressed as a fraction of each sphere's distance from ball number 1. Analyzing the data in this manner provides an indication of how well the individual machines could measure two-dimensional features of various lengths. As evident from the plot, the majority of the machines are within $\pm 50 \mu\text{m/m}$ of feature length. Although those data are correct as presented, they are somewhat misleading over short distances where the non-repeatability of the CMM tends to be the predominate error source. In this regime the distance

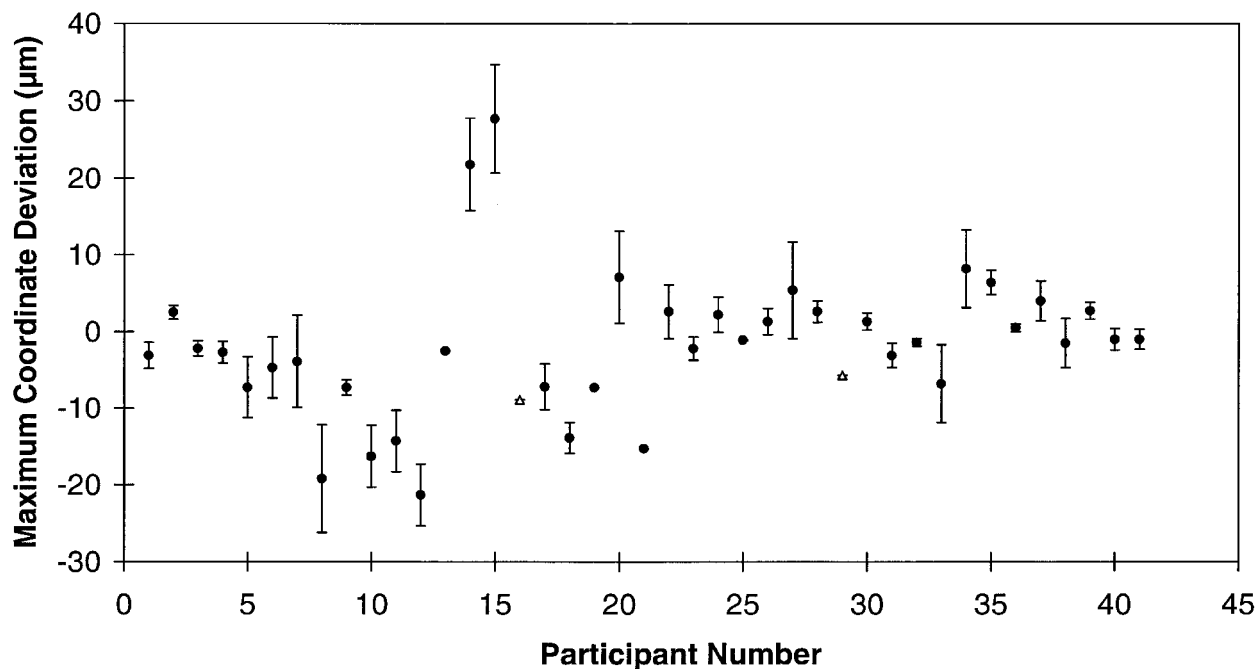
Fig. 5. Maximum coordinate deviations (from the calibrated values) along with participants measurement error estimates. The deviations are represented by the solid circles and the error estimates by the error bars. Several participants did not provide an error estimate and their deviations are denoted by the triangles.

Data reporting for this round robin, by the participants, was supposed to include an estimate of the "measurement error" which was defined as 3 standard deviations of the observed measurements arithmetically added to any estimated systematic errors.¹ Providing an estimate of their measurement error proved to be difficult for some of the participants, with responses varying from the estimates as requested to no estimates at all. Figure 5 shows the measurement error estimates (\pm) plotted around the maximum sphere center coordinate deviation reported by each participant. These deviations were chosen without regard to ball number or coordinate (X or Y).

It can be seen from this plot that the maximum deviations for a majority of the participants are within ± 10 μm . However, as was previously discussed there are additional error sources not revealed by the ball plate measurement results which can further degrade actual CMM performance. Therefore, it is somewhat disturbing that over 75 % of the participants failed to correctly estimate their measurement error on at least one of the ball plate spheres. (Figure 5 does not necessarily represent the worst case error estimation since the maximum coordinate deviation and the worst case error estimates need not occur on the same ball.) This further supports the call for more realistic CMM uncertainty estimation technique development by the CMM community as a whole.

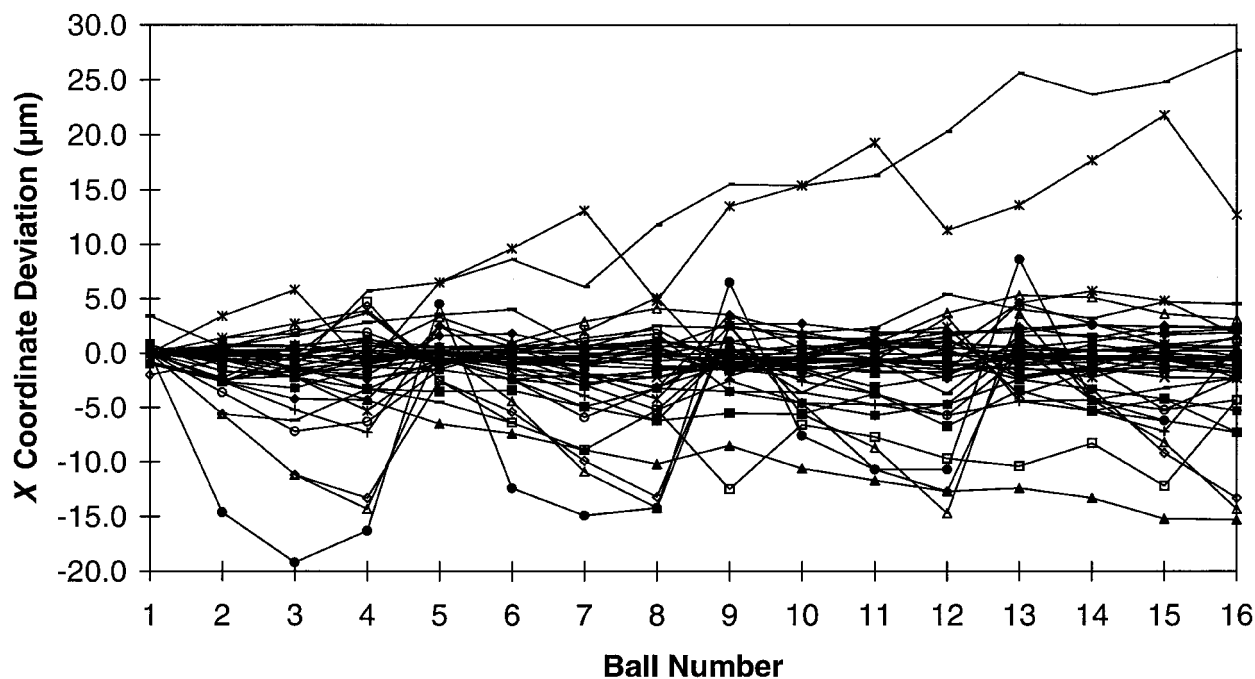
Fig. 6. X coordinate deviations, from the calibrated values, for all round robin participants.

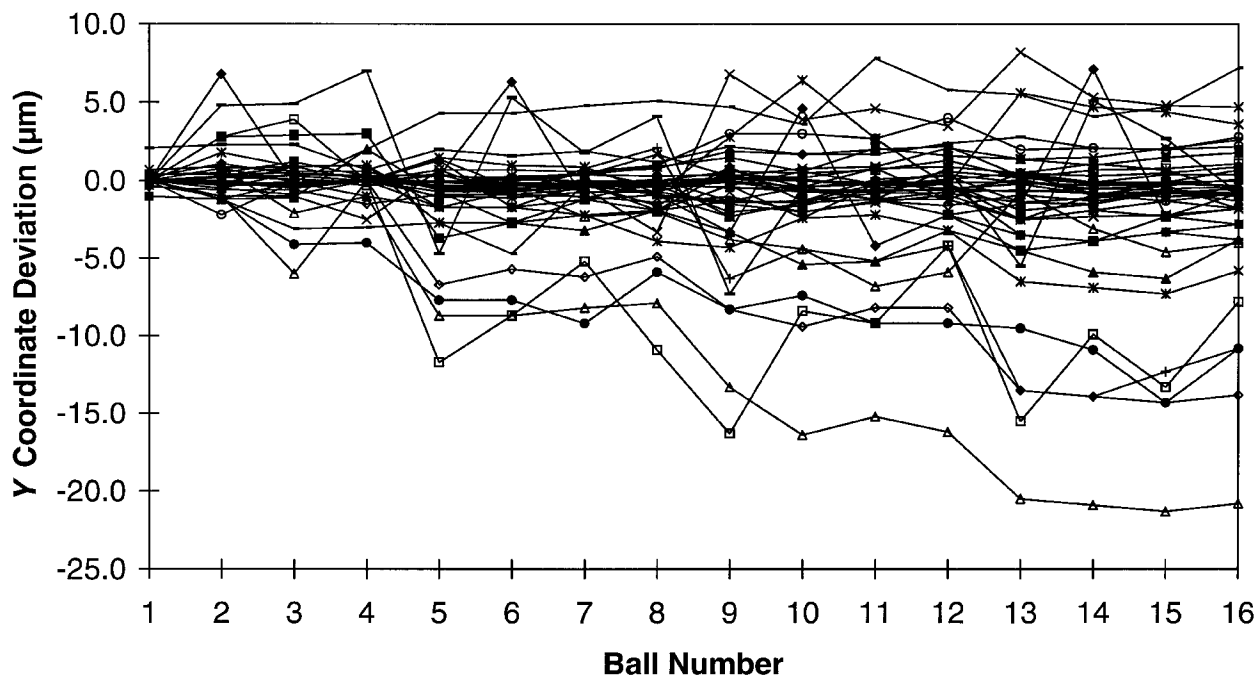
Fig. 7. Y coordinate deviations, from the calibrated values, for all round robin participants.

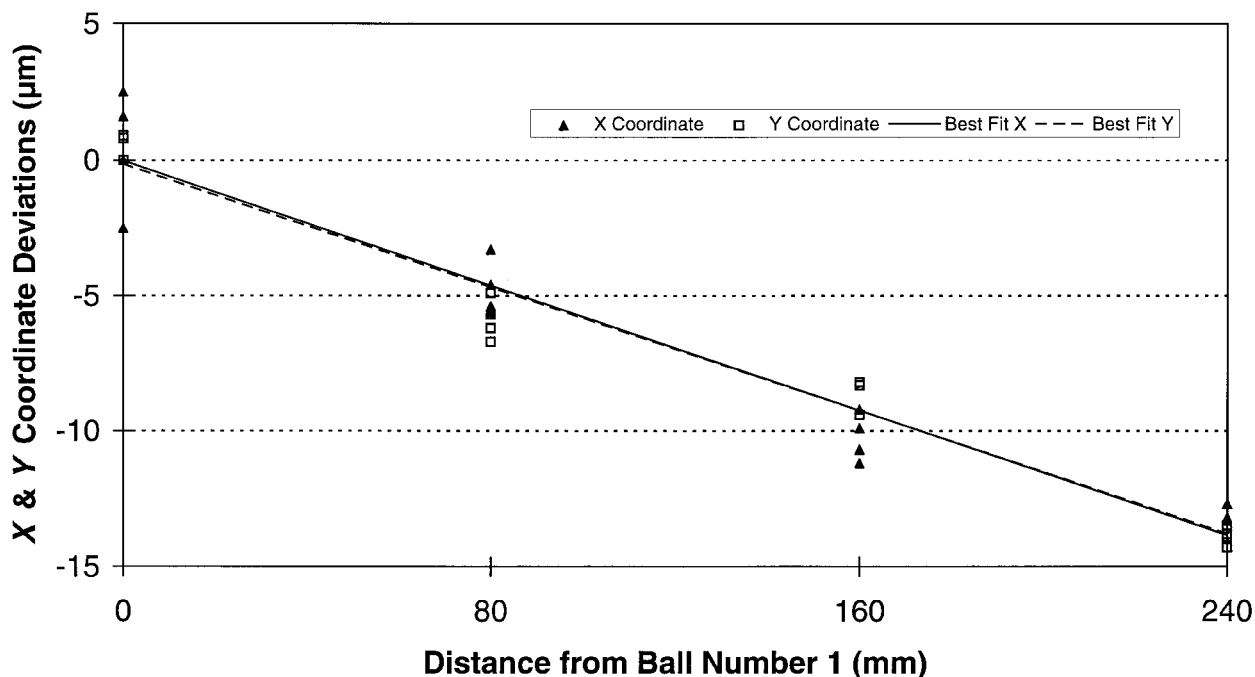
Fig. 8. A thermal error indicated by one participant's data, likely caused by improper thermal compensation of the CMM scales. The error here is approximately $54 \mu\text{m/m}$ indicating a temperature difference of 6°C to 7°C ($\sim 11^\circ\text{F}$ to 13°F).

Without imposing a rigorous measurement strategy on the participants, it would be difficult to deconvolve all of the individual errors for a series of independent ball plate measurements such as this round robin data. This is due to the highly interdependent nature of the these errors. However, we may examine the individual X and Y coordinate deviations looking for patterns in the data. As can be seen from Figs. 6 and 7, much of this data display a systematic structure, and in some cases, it is possible to identify one or more of the dominant errors. For instance, by comparing the X and Y coordinate deviations for a single set of measurements, it is possible to identify relative scale errors and/or thermal errors. If the deviations of the individual X and Y ball coordinates are approximately equal, as in Fig. 8, then a thermal error is suspect. This type of error could result from a failure to properly correct for ball plate expansion, CMM scale expansion, or both, when the measurements are made at a temperature other than the standard reference temperature (20 °C). The error shown in Fig. 8 is most likely the result of correcting the measurement data for ball plate thermal expansion while failing to correct for the CMM scale thermal expansion. This would account for the negative trend in the data, amounting to an error of approximately 54 $\mu\text{m}/\text{m}$ indicating CMM scale temperatures of 26 °C to 27 °C (79 °F to 81 °F)—which is representative of many manufacturing facility environments.

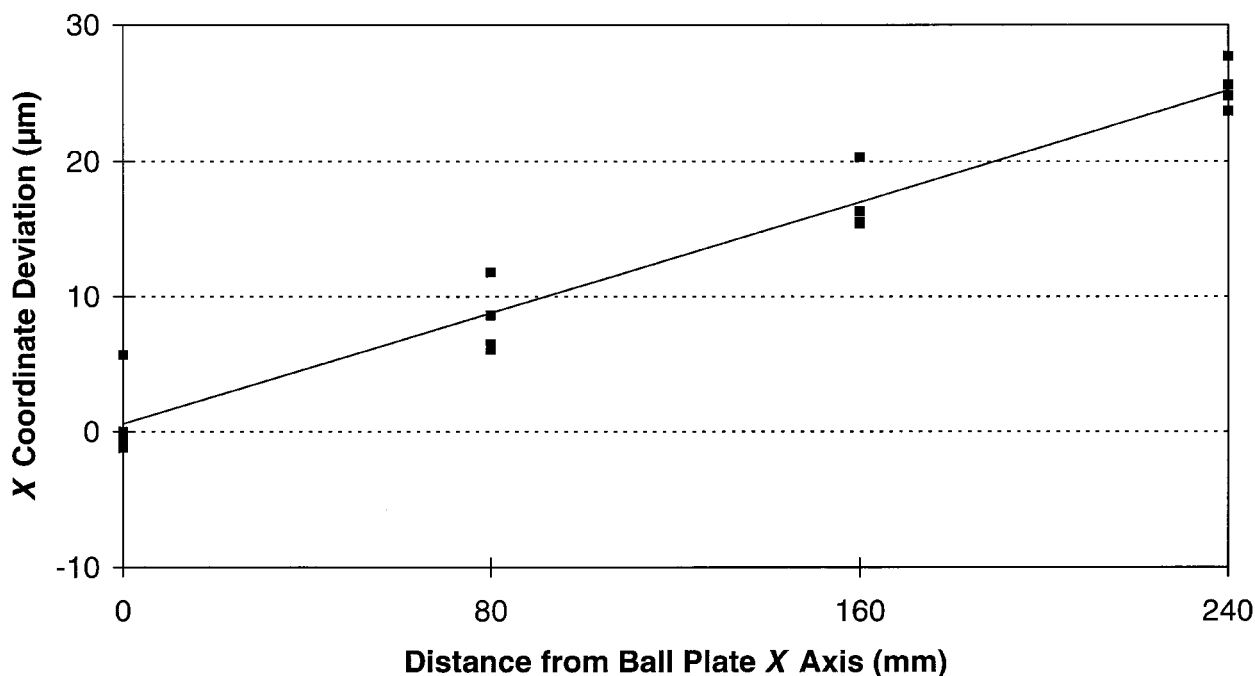
Fig. 9. One participant's data showing an out-of-squareness error. In this case the error is $100 \mu\text{rad}$ (approximately 20 arcseconds).

Another identifiable error is the out-of-squareness between the two measurement axes. Since the X axis of the ball plate was defined by the plate coordinate system, any squareness error would appear as an out-of-squareness of the Y axis with respect to the X axis. (The assignment of out-of-squareness to either of the axes is purely arbitrary as long as the magnitude, direction and effect on the measured coordinates is understood.) Therefore, by viewing the X deviation data in groups of nominally equal Y coordinates, any out-of-squareness between the X and Y axes will become apparent. Figure 9 shows evidence of a classical out-of-squareness error for one participant's CMM. In this case the out-of-squareness is calculated as 100 microradians (approximately 20 arc seconds) of error.
